*Early Domestic Architecture  
of Connecticut*

*By J. Frederick Kelly*

J. Frederick Kelly, A.I.A.

New Haven: Yale University Press

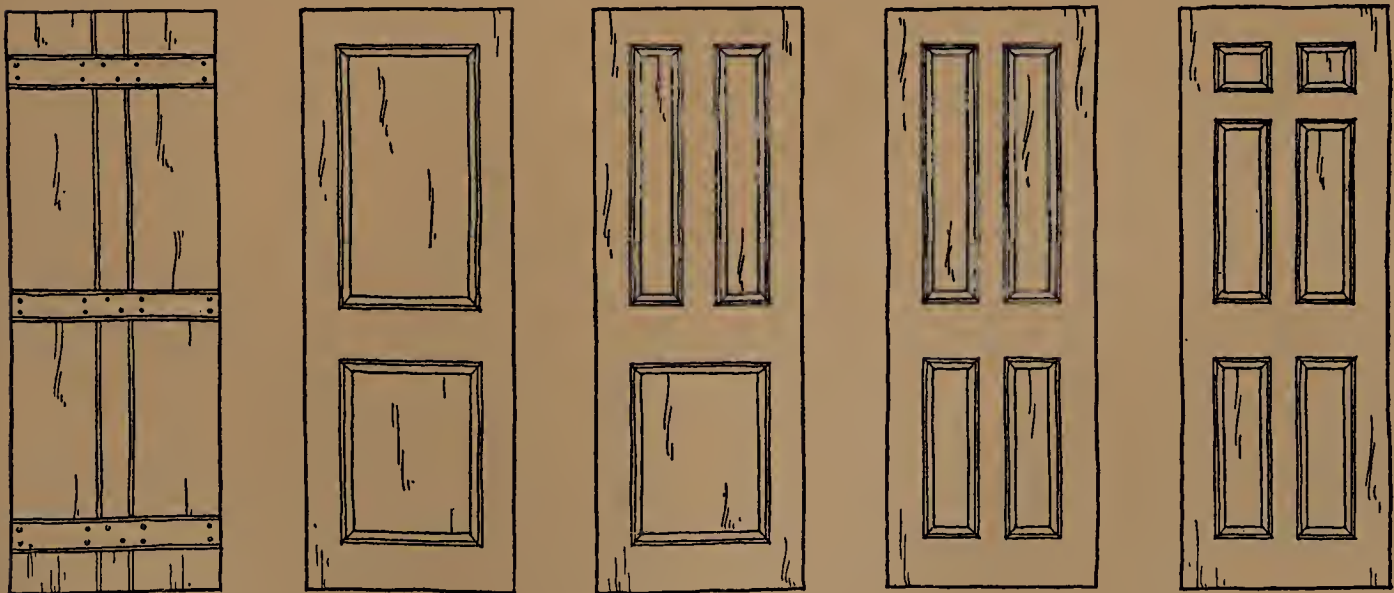
FIGURE 143.

The gradual evolution of the interior door forms is shown in Figure 143, beginning with the earliest simple form of batten construction, and terminating in the most elaborate type of six panels. Two- and three-panel doors are the earliest forms of the panelled type. Their construction was very simple, consisting of cross rails tenoned into the two vertical stiles and enclosing bevel-edged panels. Such doors are always extremely thin—generally  $1\frac{1}{8}$  inches. A later, and the commonest, type is the door composed of four rectangular panels. Doors of batten form and the two-, three-, and four-panel types belong especially to the house of central-chimney plan. Where the house is of the lean-to type, it is common to find panelled doors in the two front rooms, often of both floors, and batten doors in the rear part. A somewhat later development is the door of six panels, which occurs most commonly in central-hall houses or in those which, though of central-chimney plan, have two full stories throughout. In many cases the doors in a house are much older than the house itself, having been salvaged

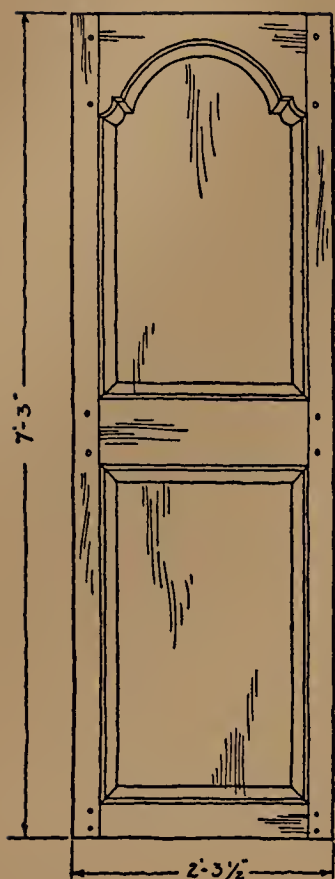
FIGURE 144.

As a variation of these types, two-panel doors are occasionally met with which have a panel of curved termination in the upper half, as shown in Figure 144. Doors of this type appear to be principally confined to houses in the Connecticut River Valley. Where round-headed doors were employed, as in the parlor of the Webb-Welles house in Wethersfield (1751), the upper panels of the doors naturally repeat in their contour the shape of the door itself. (Figure 171.)

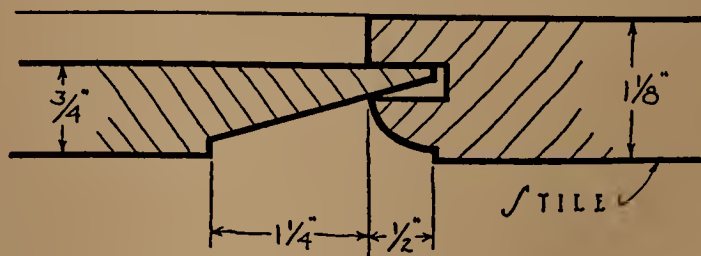
FIGURE 145.

In cross section, panelled doors are almost invariably the same. The panel edge is bevelled on one side and held in place in the rabbets of the stiles and rails by a quarter-round bead or moulding which is integral with them. (Figure 145.) Inasmuch as the panels were generally a quarter of an inch thinner than the stiles and rails, a simple sinkage occurs on the reverse side of the door. Rails and stiles were never greater than  $1\frac{1}{2}$  inch in thickness; the average measurement was  $1\frac{1}{8}$  or  $1\frac{3}{8}$  inches. The jointing of the stiles and rails is always by means of the conventional mortise-and-tenon joint, held together by wooden pins. White pine is, without exception, the material of which both exterior and interior doors were made.

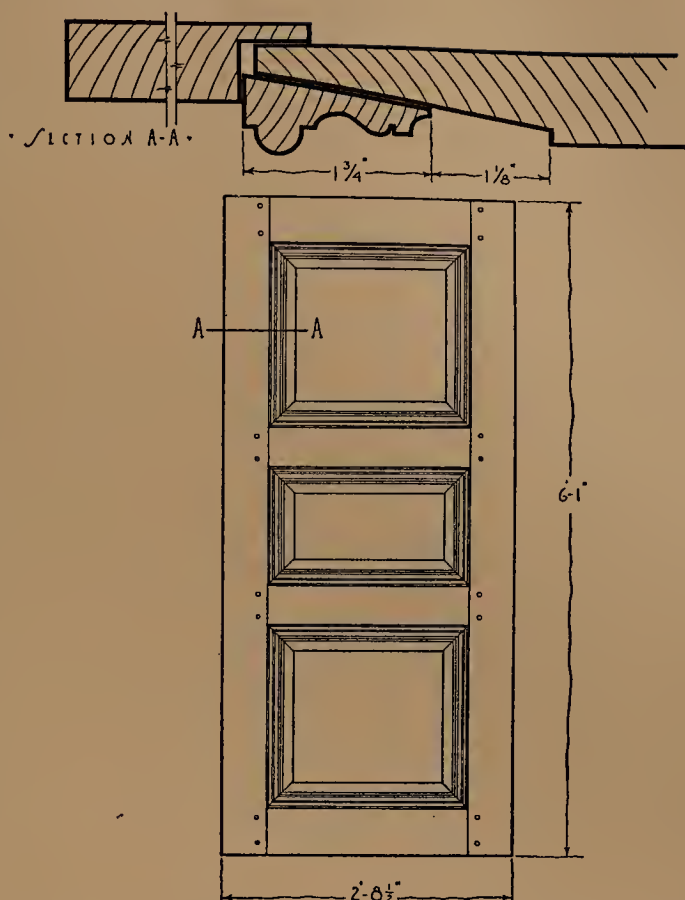
FIGURE 146.

A very unusual door is that shown in Figure 146, from the older Williams house in Wethersfield (*circa* 1680). As will be seen from the sectional drawing, the panels are held in place by a heavy raised moulding of comparatively strong projection.

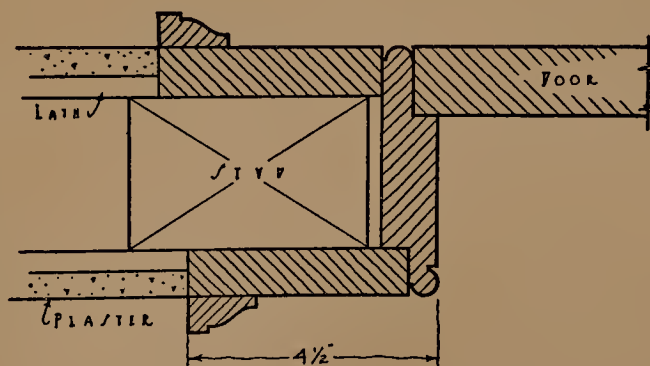
FIGURE 147.

Early forms of interior door casings or "trim" were very simple, generally consisting of a narrow casing about four inches in width, flush with the plaster, to the outer edge of which a simple band moulding was applied. (Figure 147.) A typical form of trim of later date is that shown in Figure 148. Trim of this sort is usually to be found only in late houses of the central-hall type.

• DOOR CASING •

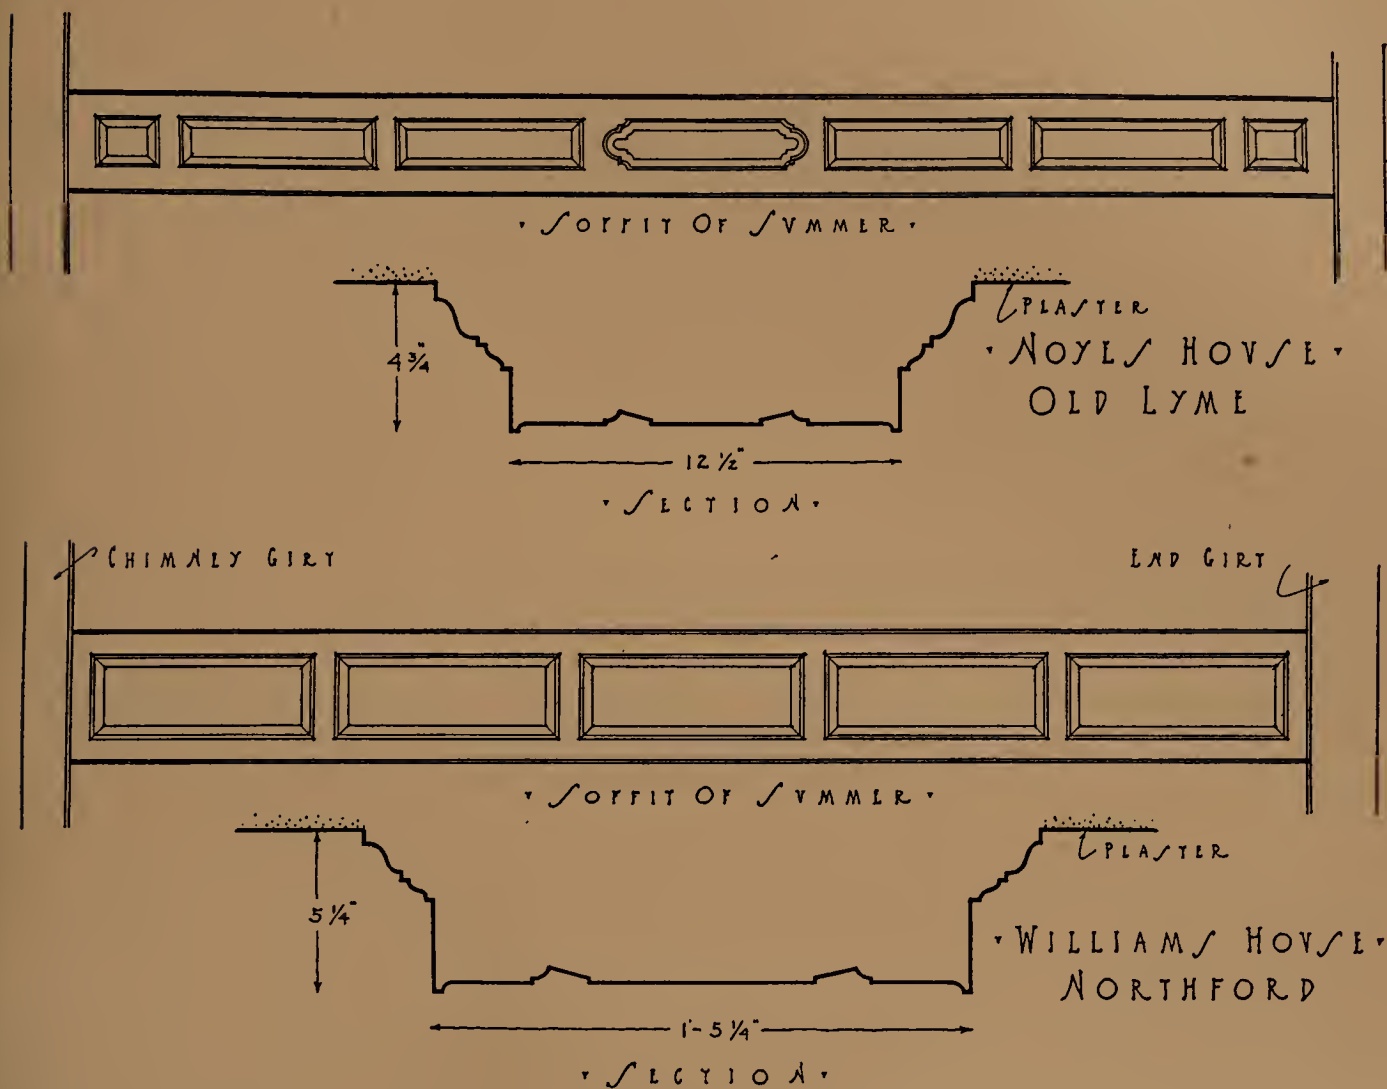
FIGURE 150.

ford (1750) are finely panelled on the under side. (Figure 150.) The treatment of the summer of the Noyes house is of greater elaboration than any which the writer has seen in Connecticut.

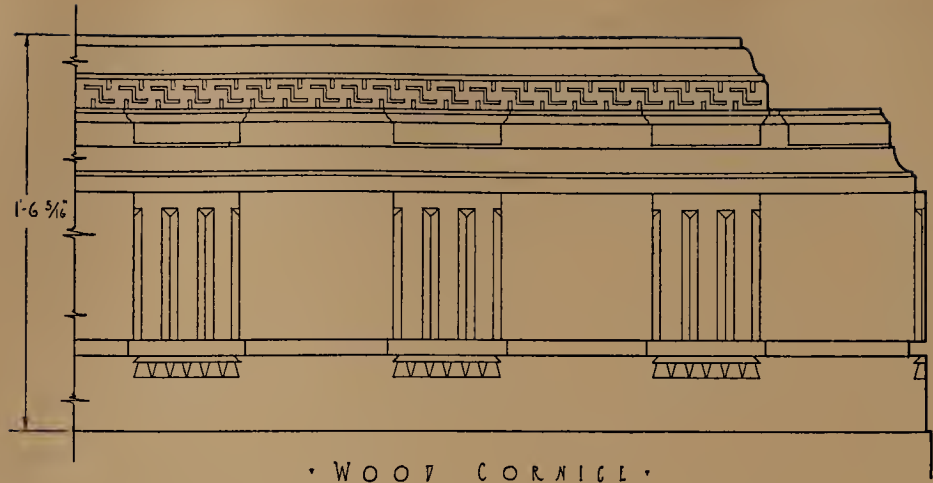
FIGURE 151.

• WOOD CORNICE •  
 ✓ DEMING HOUSE - COLCHESTER ✓

both in the parlor and throughout the central hallway of the first floor, is very handsome. (Figure 151.) The vertical fascia below the crown moulding is carved with a variation of the Greek fret, and delicate modillion brackets are introduced below it, bearing in turn upon a bed moulding carved with the Classic egg and dart. A somewhat similar treatment is to be seen in the Champion house at East Haddam, and in the central hallway of the Sherman house in Yantic (1785) and the Gay house in Suffield (1795). The two last-named examples, however, are much simpler and have no carving. (Figure 152.)

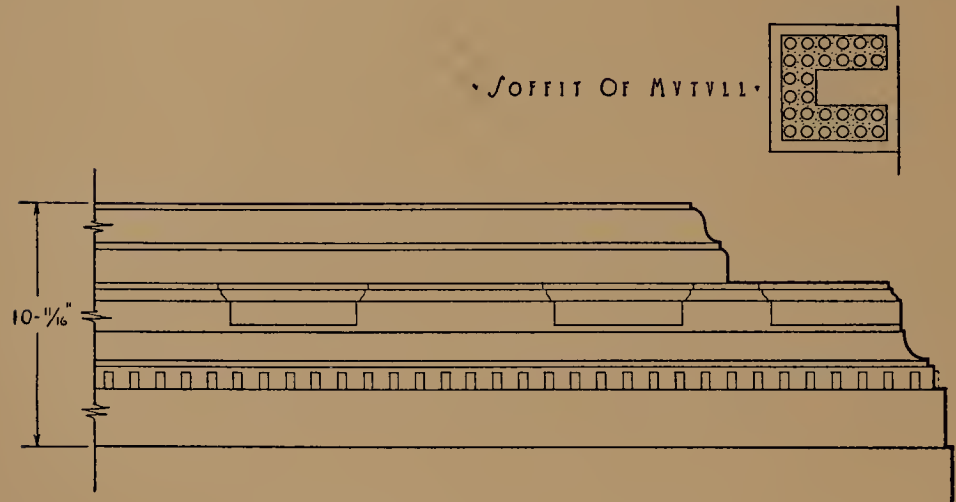
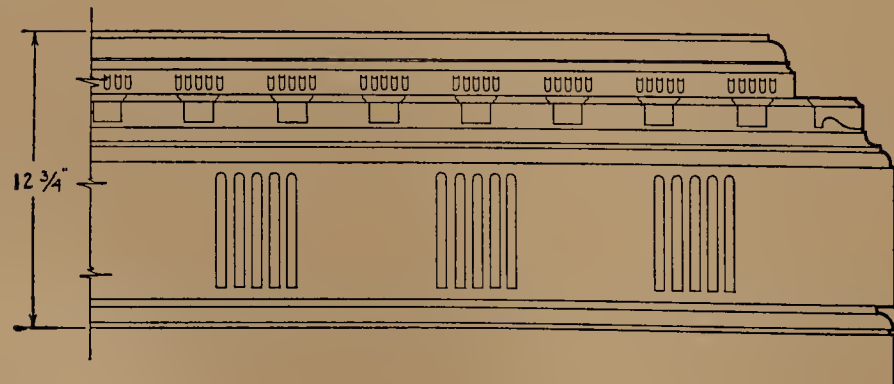
FIGURE 152.

• SOFFIT OF MITRE •

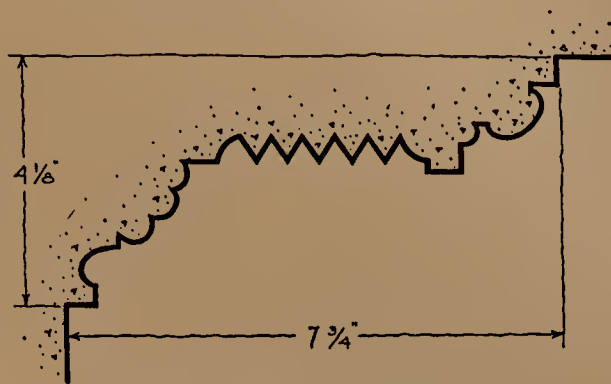
FIGURE 153.

• PATTEN HOUSE - HARTFORD •

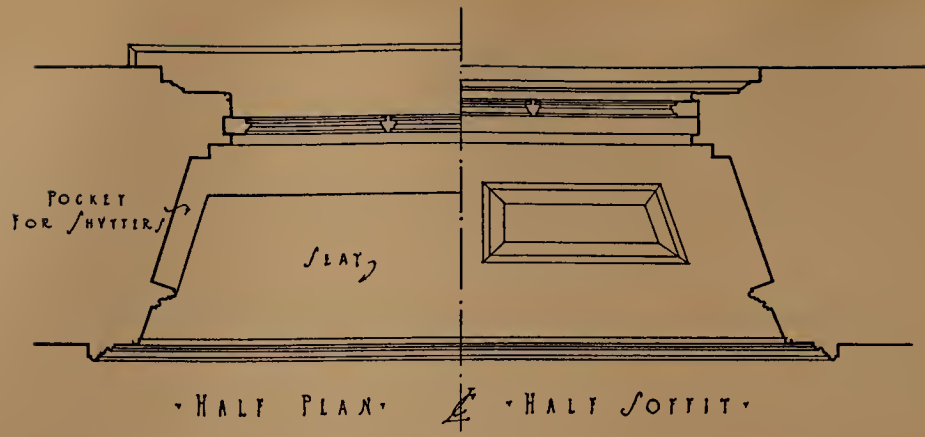
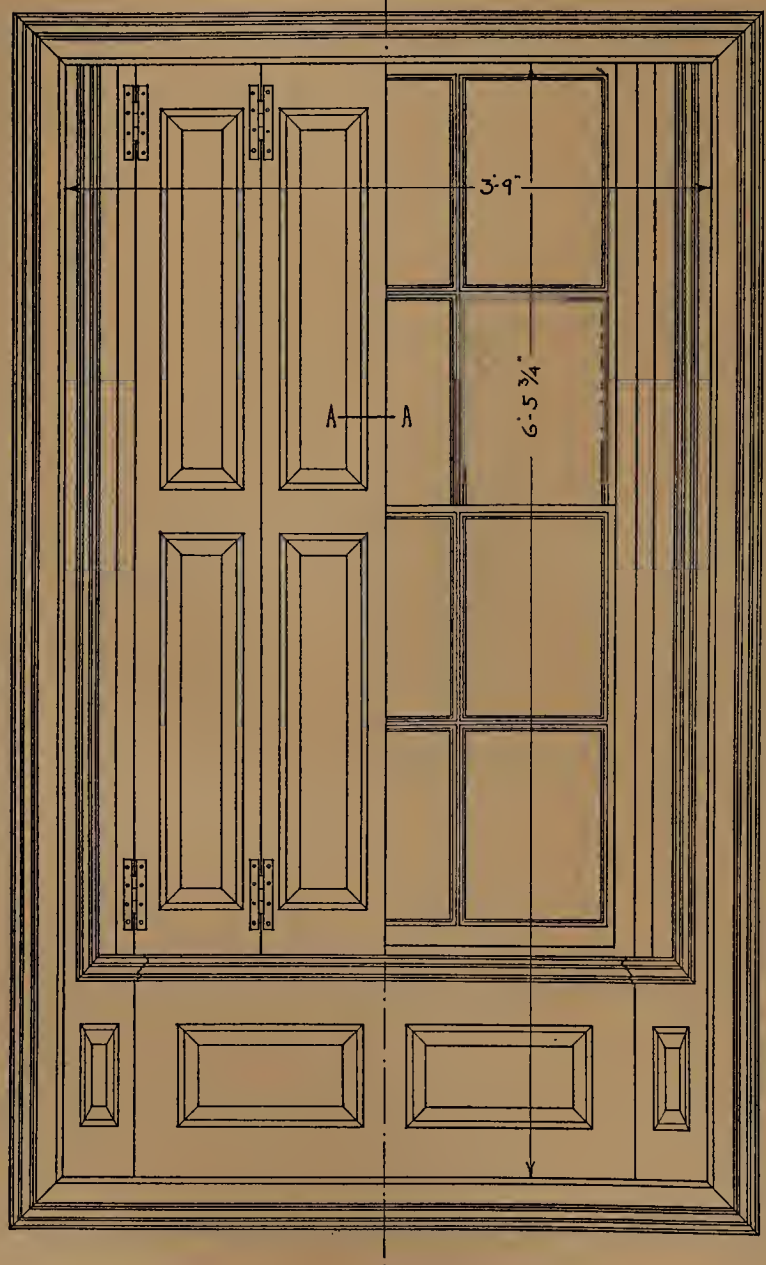
INSIDE SHUTTERS  
 CHAFFEL HOUSE - WINDSOR  
 FIGURE 154.

some cases these shutters slid into pockets formed in the thickness of the walls and specially constructed to receive them. In the so-called "Beehive" in the town of Andover, and in the Bildad Phelps house at Hayden Station (1780), the shutters are of this variety. Very handsome shutters of the folding type, each section of which is panelled, may be seen in the Governor Trumbull house in Lebanon (1753). The top panels of these shutters are pierced with heart-shaped openings—a feature which, since it admits some light and air, is useful as well as decorative. (See Plate XX.)

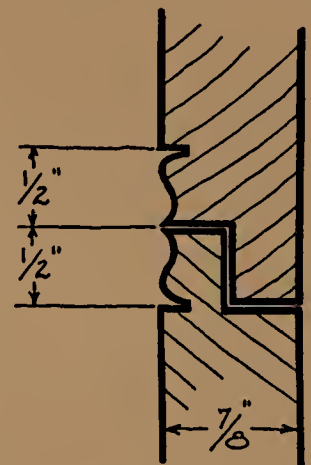
FIGURE 155.

In early work, wainscot was never applied to the ceiling: the joists of the floor above, planed and sometimes beaded, were always left exposed. The use of wainscot was confined, then, to vertical wall surfaces. Occasionally, though very rarely, some wood other than white pine was employed for wainscot. The wainscot on the second floor of the Thomas Buckingham house in Milford, asserted to have been built in 1639, is of butternut; that on the second floor of the Caleb Dudley house in the Town of Guilford (*circa* 1690) is of whitewood. The wainscot of the Dudley house is made up of very wide boards, averaging twenty inches in width, halved together at the joints, which are finished with a very interesting quirk moulding, shown in section in Figure 155.

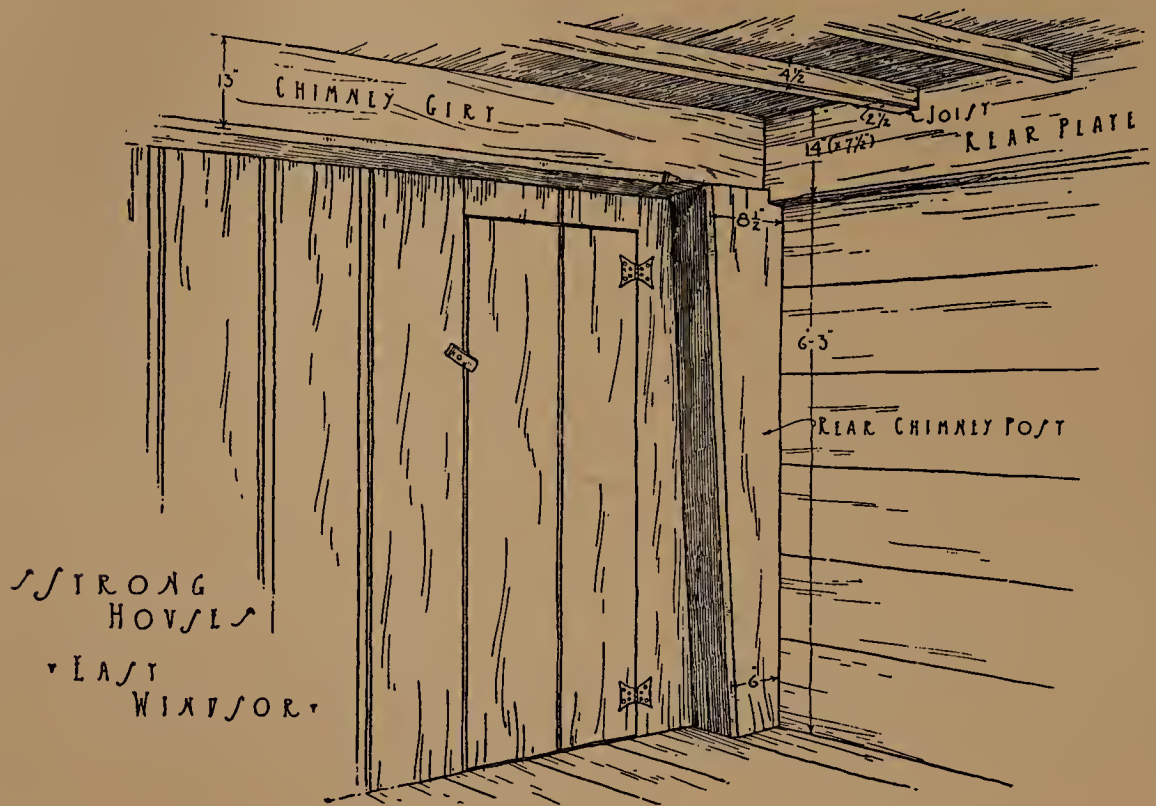
FIGURE 156.

A typical example of the use of wainscot is shown in Figure 156, which is taken from the second floor of the Nathaniel Strong house in East Windsor (*circa* 1700). The vertical joints display the customary bead-and-bevel section, used so commonly later on for panelling—a fact which is responsible for the term “panel sheathing,” sometimes applied to such wainscot.

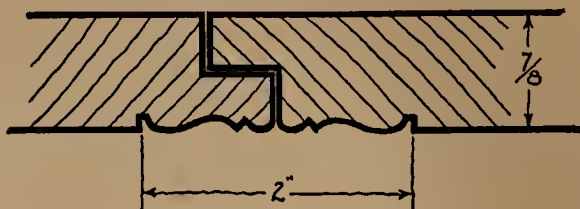
FIGURE 157.

The hall of the Thomas Lee house in East Lyme—the part built in 1664—has walls finished with vertical wainscot, the jointing of which is of the same section. The room above it on the second floor—the hall chamber—is finished in a similar manner. (Figure 157.)

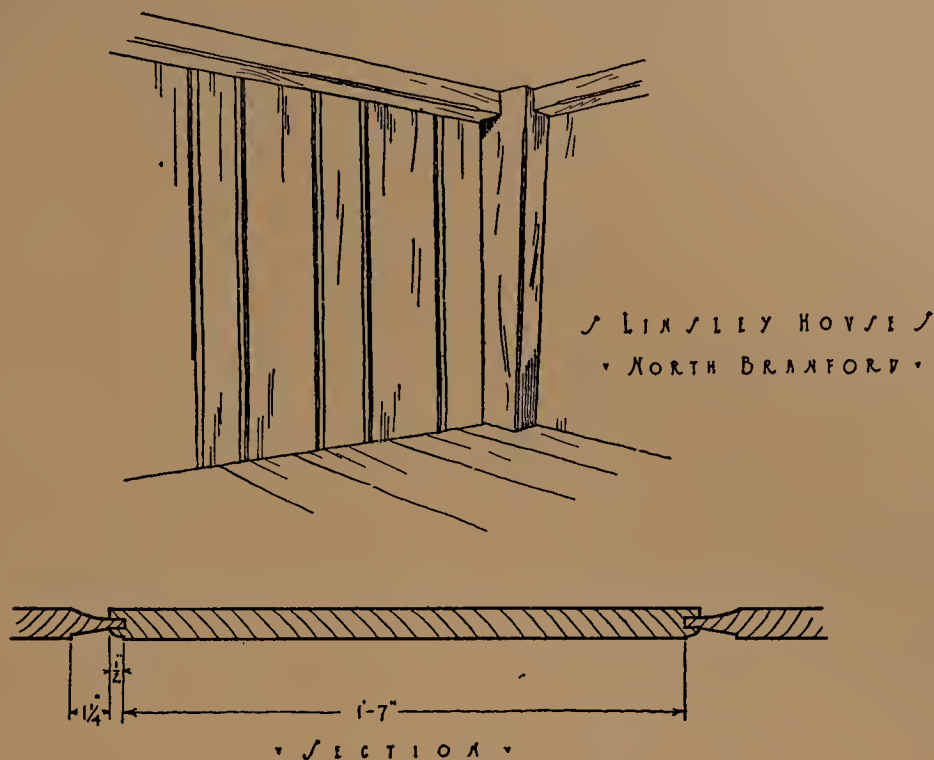
FIGURE 158.

In the Linsley house in the town of North Branford, built *circa* 1700, the only wainscot remaining at the present time is that which covers the fireplace wall of the parlor chamber. (Figure 158.) The white pine boards which entered into its construction are of two widths, thirteen and nineteen inches, placed alternately. The narrower boards have bevelled vertical edges, and the broader ones, which are really stiles, enclose their edges between a

rabbet at the back and a quarter-round bead formed on the exterior or visible surface. The same treatment is to be found on the fireplace wall of the parlor of the Tyler house in Branford (*circa* 1710); although the boards there, which are also pine and of similar "panel" section, are much narrower—eight and nine inches.

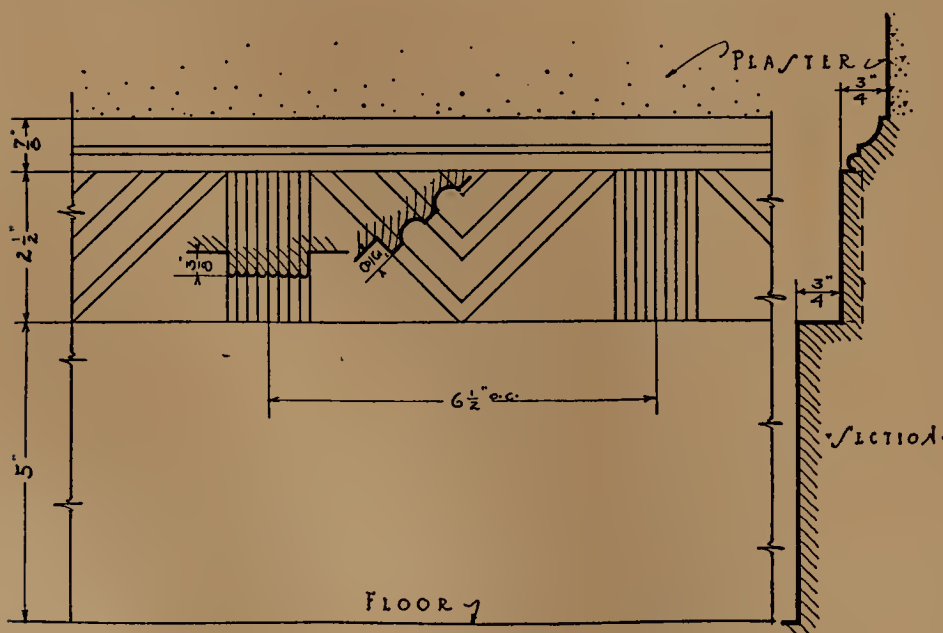
FIGURE 161.

When plaster superseded this form of wainscot, it became necessary to finish against the floor with a baseboard, the surface of which was set flush with the plaster. It might almost be said that the original wainscot shrank to the present baseboard. In later examples, the baseboard was projected beyond the face of the plaster, sometimes moulded at the top, and, though rarely, carved, as is that in the parlor of the Rectory at Monroe (*circa* 1810). (Figure 161.)

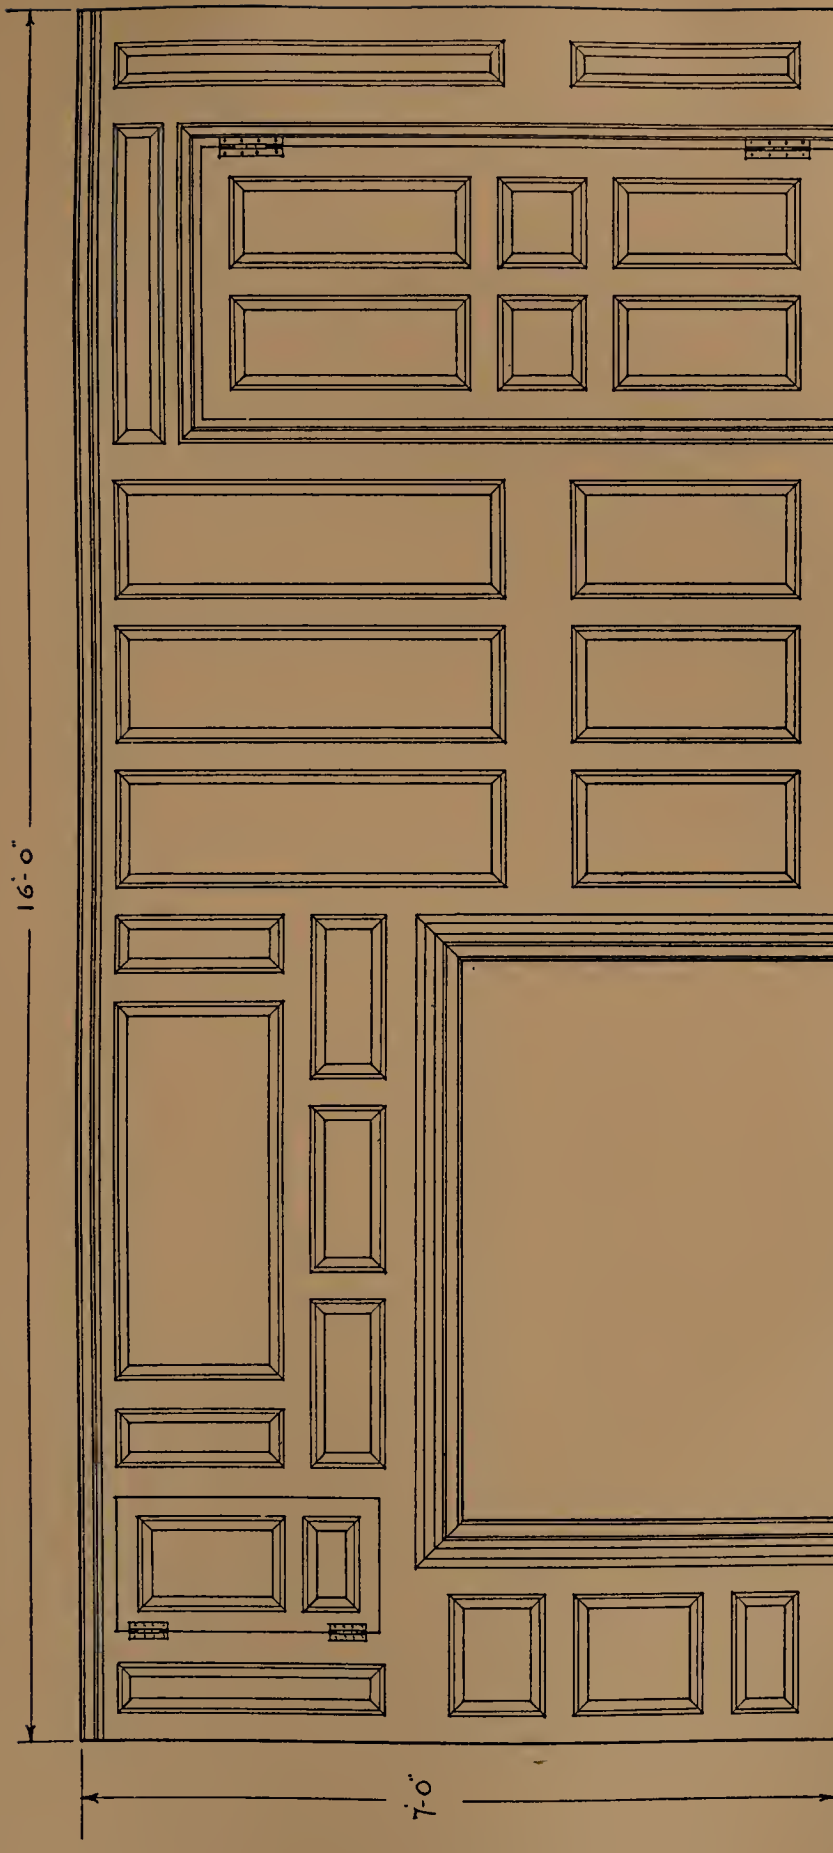
FIGURE 162.

fireplace wall—that next the chimney—was entirely covered with an arrangement, or, more properly, a *composition*, of rectangular panels, secured in place by stiles and rails. (Figure 162.) The fireplace opening was surrounded by a heavy, simple “roll” moulding. No attempt was made at symmetrical arrangement, for the fireplace was rarely on the central axis of the room, and there was always a door on one side of it, opening into the porch. Although the problem of panel grouping seems never to have been worked out twice in the same manner, the result is in every case admirable.

In houses of the central-chimney type of plan, the panelling arrangement was generally simple and dignified. A typical example is that from the Forbes or Barnes house in East Haven (*circa* 1740). (Figure 162.) In later houses, especially those of the central-hall type, the panelling system became much more pretentious and elaborate. The fireplace opening was flanked on either side by fluted pilasters, carried on pedestals with panelled dies, and with caps formed by the mitered bed mouldings beneath the chimney girt, which was treated as a cornice. The parlor panelling of the Taintor house in Colchester (1703), shown in Figure 167, is an example of such treatment. This specimen is unusual because of the form of the upper row of panels, which terminates in a double curve of pleasing contour; also because of the position of the corner cupboard, which has been made a part of the panel system. Panels with this double curve termination are not common; and such work appears without exception to have been confined to the Connecticut River valley. Another example with panelling of this type is shown in Figure 168. This panelling was taken from an old house in Lyme, now demolished.

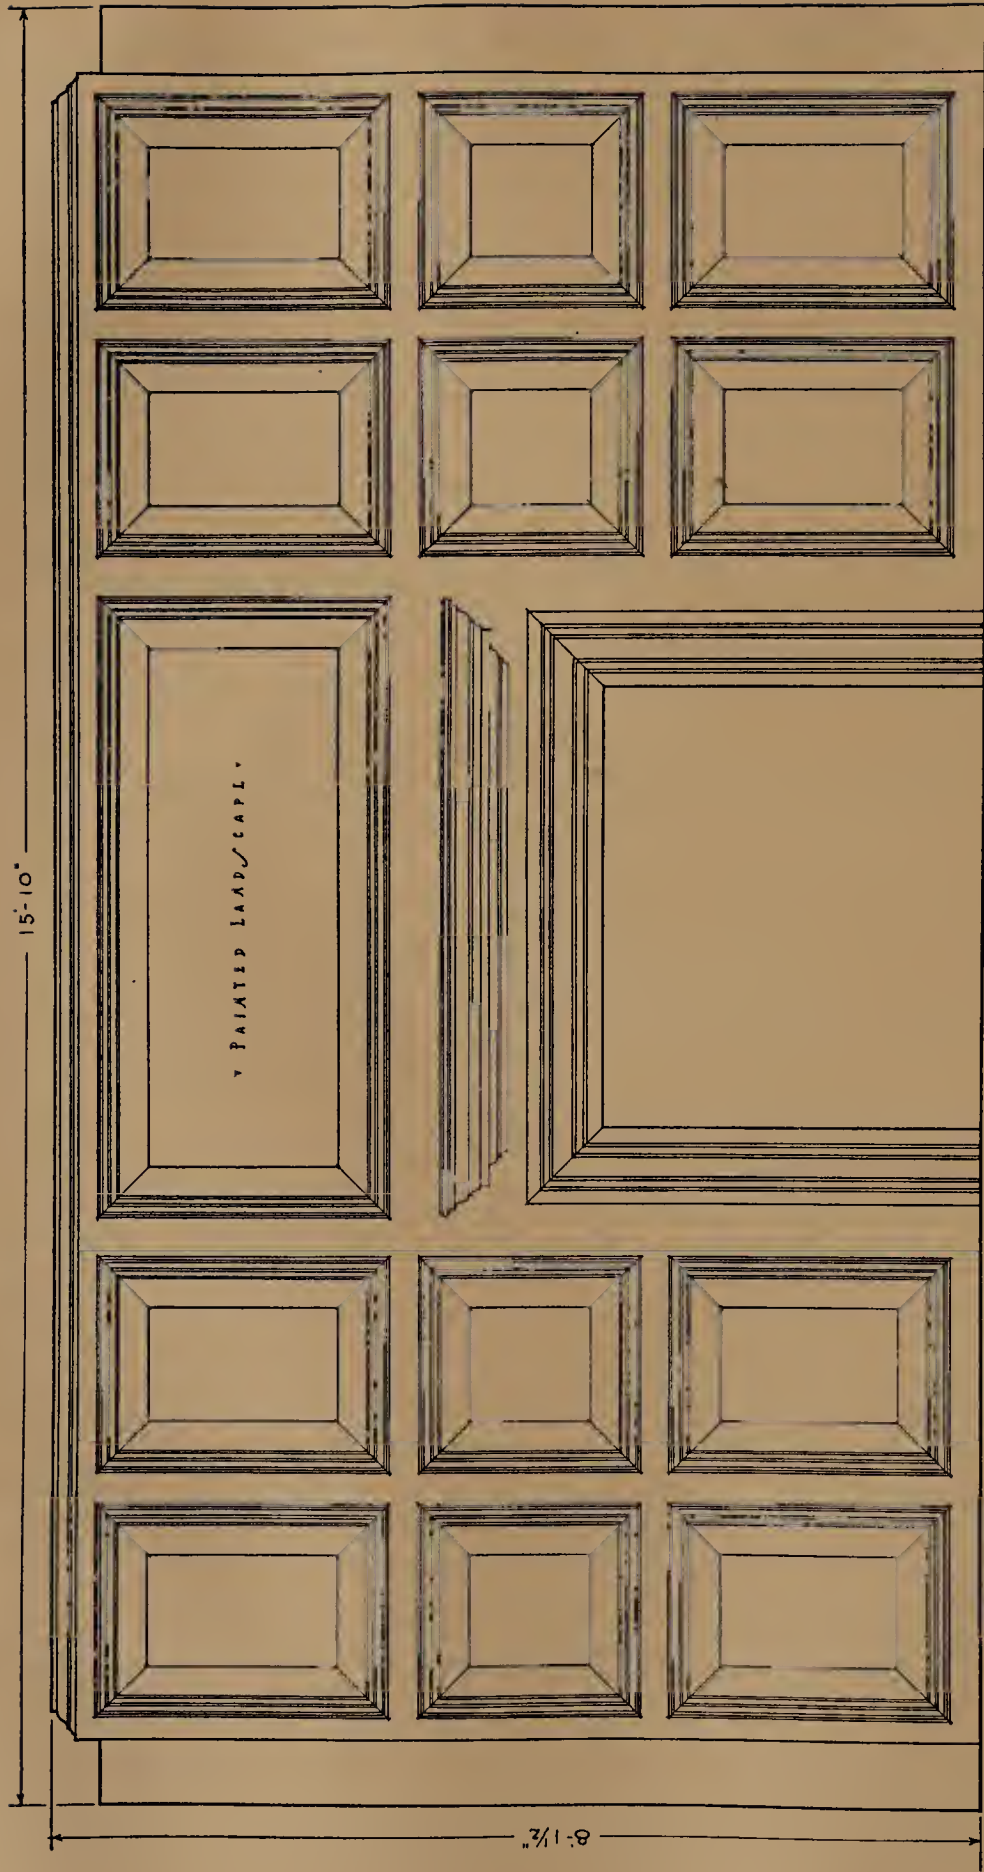
FIGURE 163.

A very early example of panelling is to be found in the parlor chamber of the Welles house in Lebanon (*circa* 1710). (Figure 163.) This panelling, which completely covers the chimney wall, is said to be contemporaneous with the house itself; and although it certainly is very early work, it is doubtful if such an early date can correctly be assigned to it. Owing to alterations carried out some time ago on the first floor, no panelling exists there to-day. In this example, the fireplace opening is framed by a very heavy and somewhat clumsy moulding of bold projection and symmetrical contour. (The earliest mouldings of this sort are nearly always bilaterally symmetrical, whereas the later examples are not. Figure 164.) Above the fireplace of this room is a mantelshelf with bed moulds beneath it, and above that in turn a single large panel, upon which is a painted landscape. Grouped symmetrically on either side are smaller rectangular panels with very broad bevelled edges. They are held in place by heavy bolection mouldings applied to the rails and stiles, so that the panels project beyond them. (Figure 165.) This in itself is a feature of very rare occurrence. The only other similar examples noted are the parlor panelling of the Chaffee house in Windsor, built 1763, and that of the Deming house in Colchester

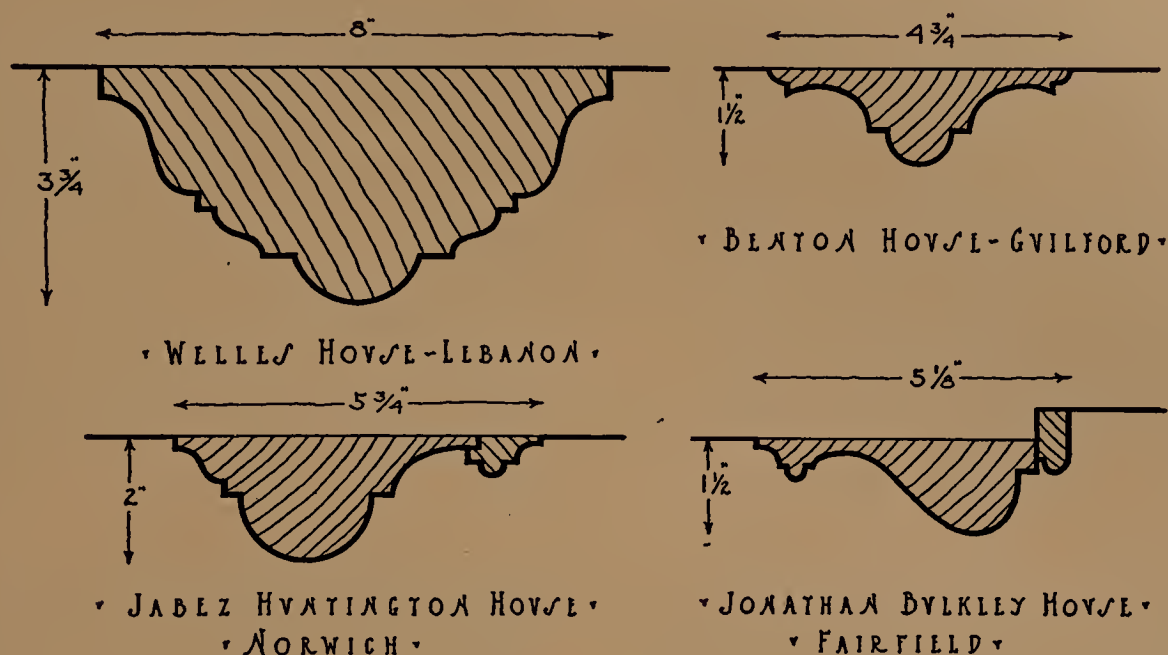
FIGURE 164.

**T**HE wood finish around the fireplace openings of the earliest houses simply consisted in most instances, as stated in the chapter on panelling, of large, heavy mouldings of bold projection. These mouldings, which were mitered at the corners, formed a frame about the fireplace opening. (Figure 164.) Often called "roll," or, more properly, bolection mouldings, they were generally used until the appearance of the Georgian mantelpiece, after the Revolution.

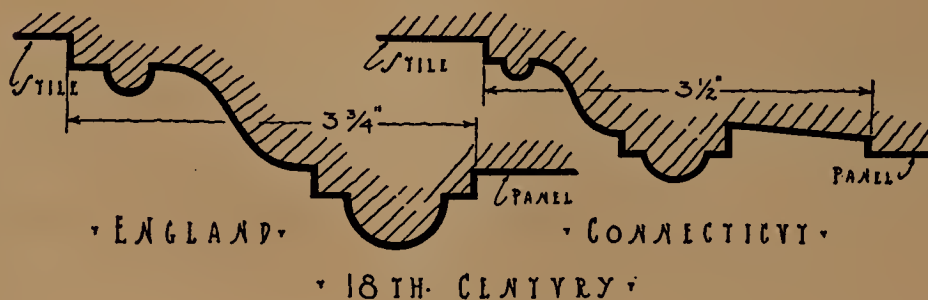
FIGURE 166.

(1771). In the last named also, the surfaces of the panels project beyond the stiles and rails. Figure 166 shows an interesting comparison between the panel section from the Chaffee house and similar contemporaneous work in England.

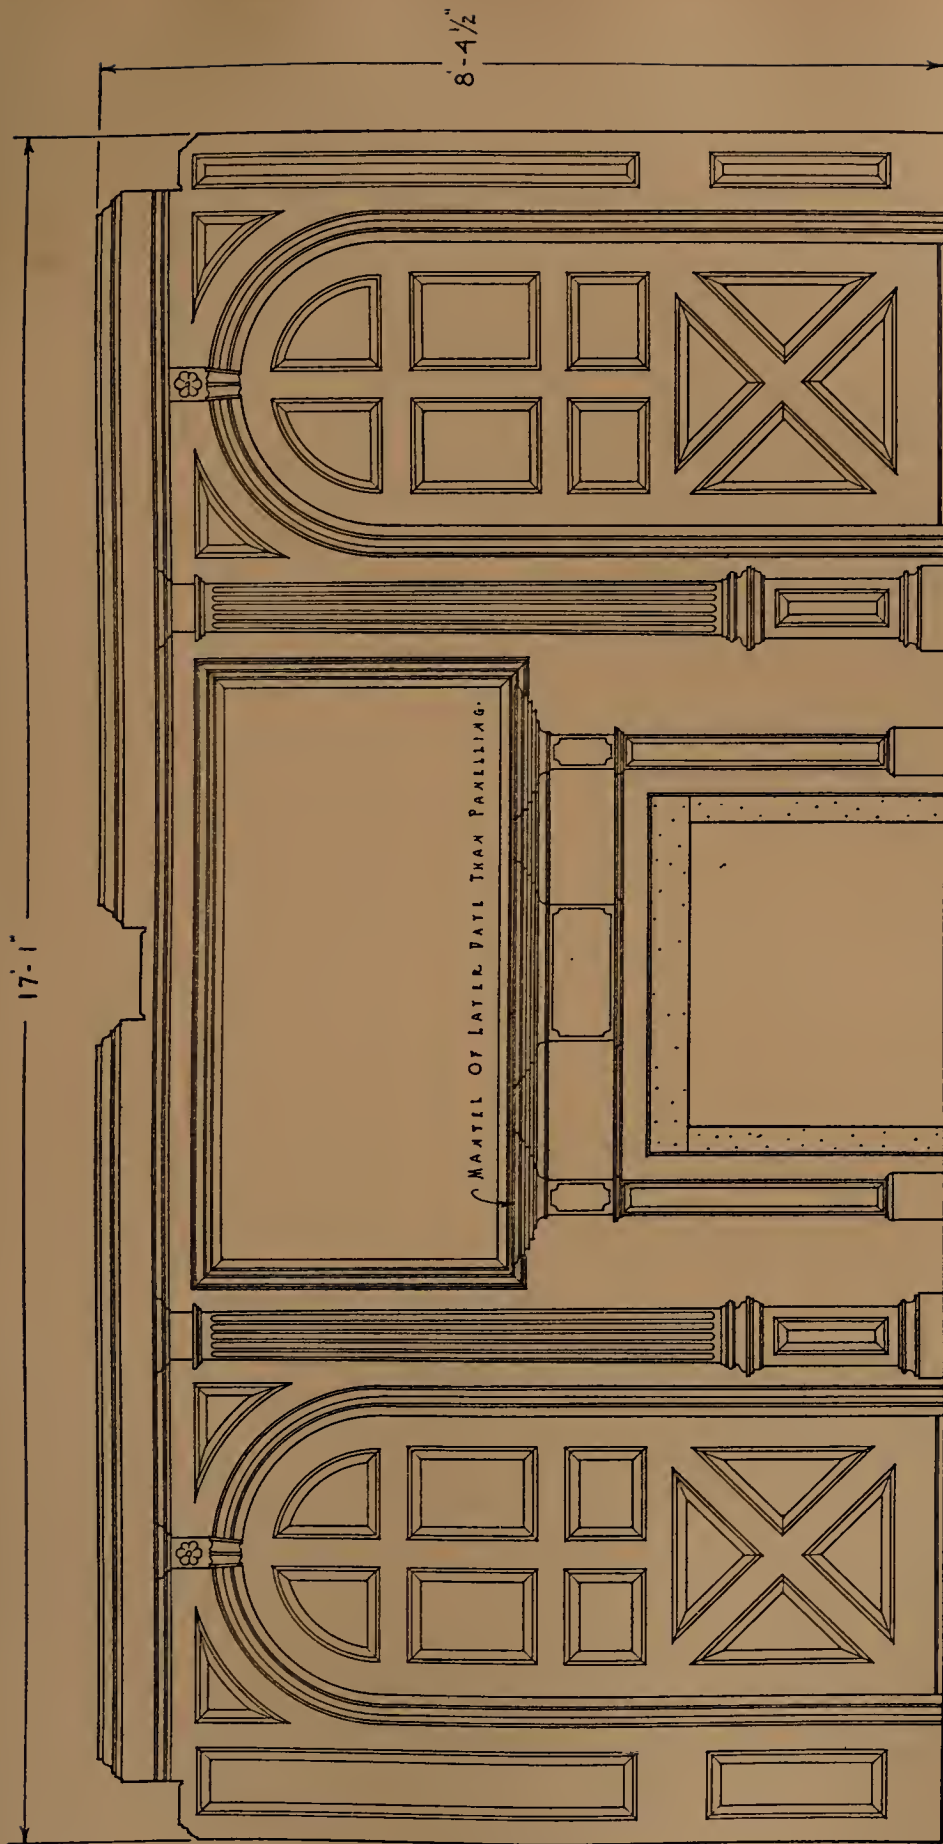
FIGURE 171.

Two examples of panelled work taken from late houses of the central-hall type are shown in Figures 170 and 171. Both display the characteristics of very late work: the composition has become more formal and perfectly balanced, and all of the detail and scale of moulding is extremely fine. The work shown in Figure 170, from the Henry Deming house in Wethersfield (1790), is in its original condition; the mantelpiece in the Webb-Welles house example (1751) is, however, a later addition. (Figure 171.)

It is probable that many of the earlier "roll mouldings" which framed the fireplace openings were removed and replaced by mantels of this type. This change occurred in the parlor of the Webb-Welles house in Wethersfield (1751), where may be seen a mantel of much later date than the panelling to which it has been applied. (Figure 171.) The subsequent introduction of mantelpieces into houses which were originally constructed at a much earlier date is of common occurrence; so that very often a house and its mantelpieces are not contemporaneous.

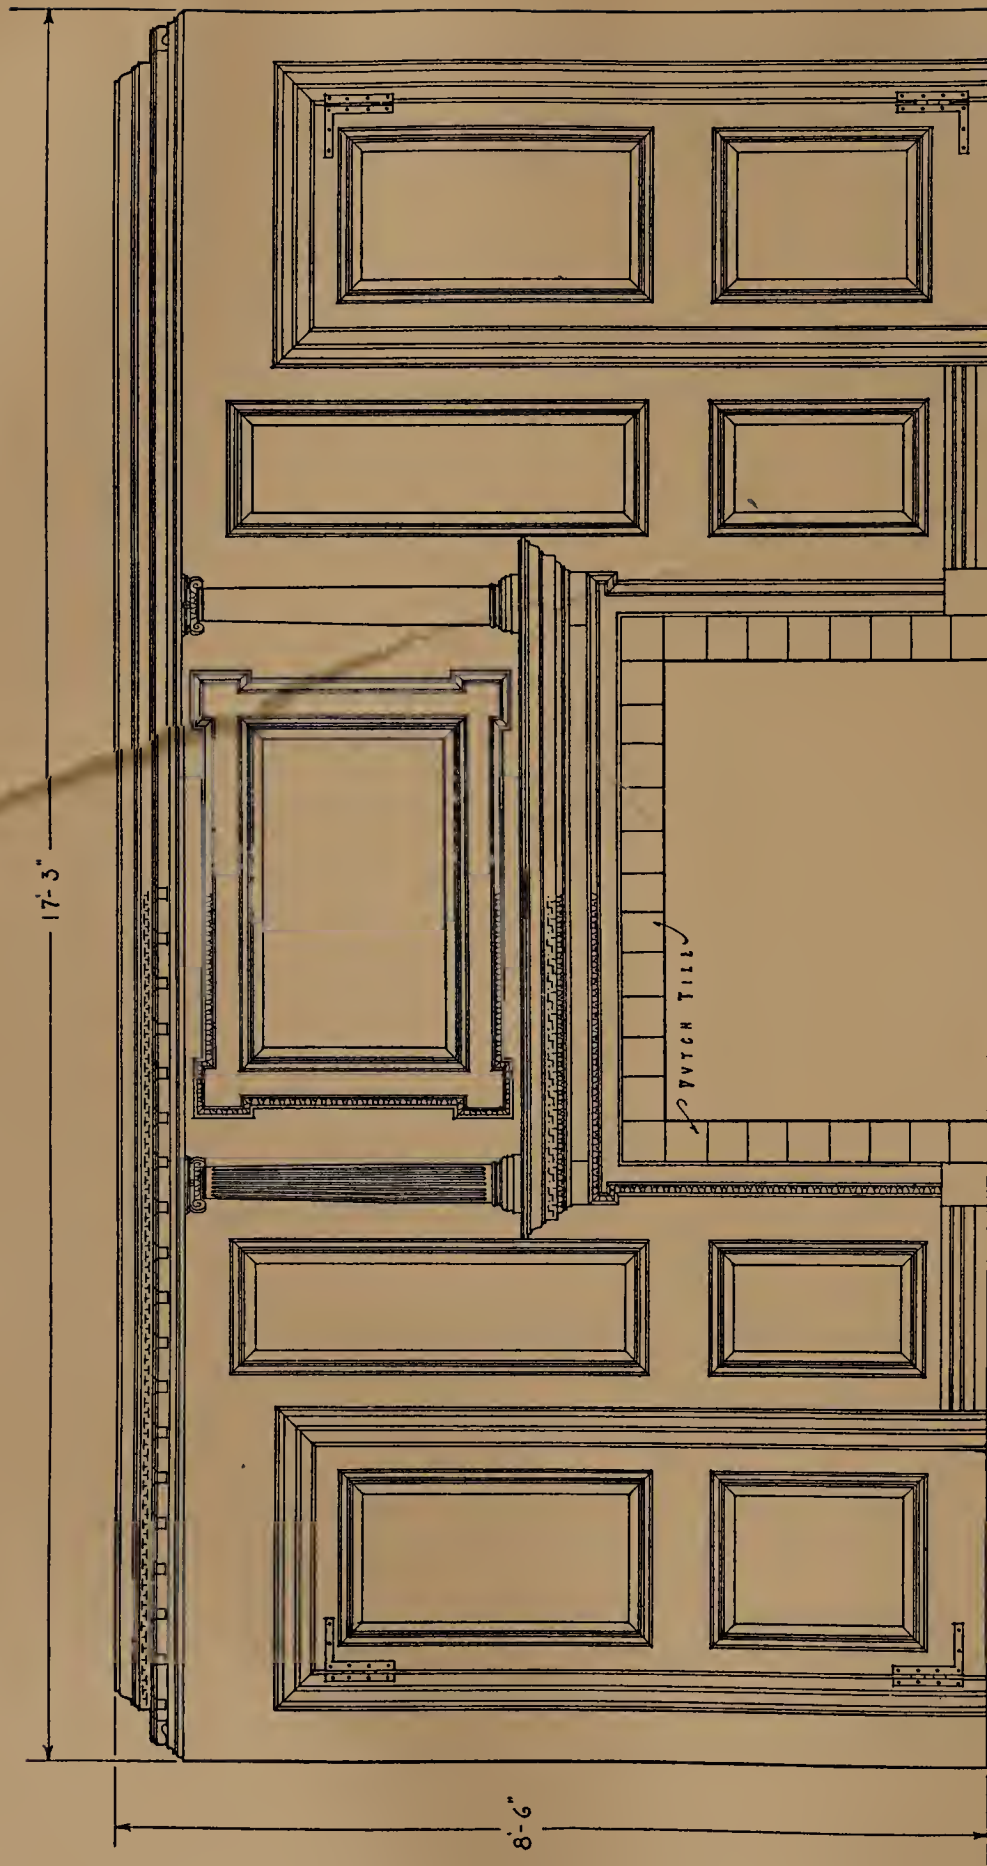
FIGURE 172.

The mantelshelf over the fireplace is sometimes found with bed mouldings beneath it and carrying narrow fluted pilasters between which is a single large panel framed by carved mouldings croisetted at the corners. The panelling of the parlor of the Deming house in Colchester (1771) is one example (Figure 172); and that in the parlor of the Silas Deane house in Wethersfield (1765) is somewhat similar. As in the Webb-Welles house, the fireplace is flanked on either side by doors to china closets or to an adjoining room. Such work is typical of the final development of panelled woodwork. It is interesting to note how the earlier and more informal arrangement gave way to this later expression of more dignified and symmetrical arrangement.

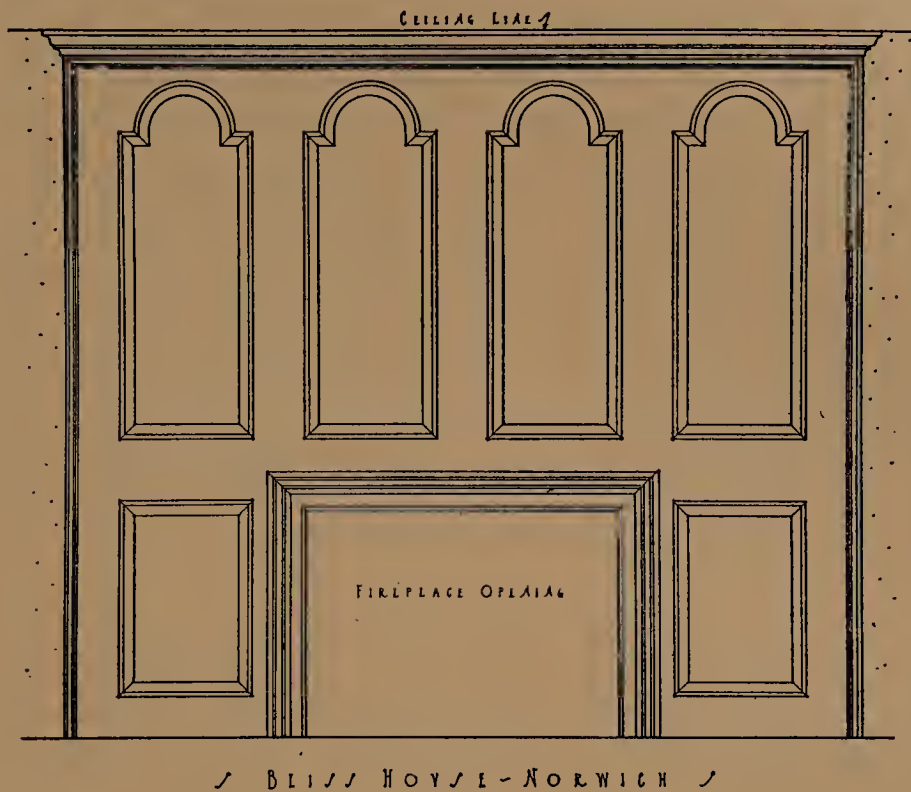
FIGURE 173.

Some of the houses in Norwich exhibit in their panelling an interesting variation from the common treatment, not ordinarily found elsewhere: the formation of a panelled motive around and above the fireplace opening, the remainder of the fireplace wall being simply finished with plaster. (Figure 173.)

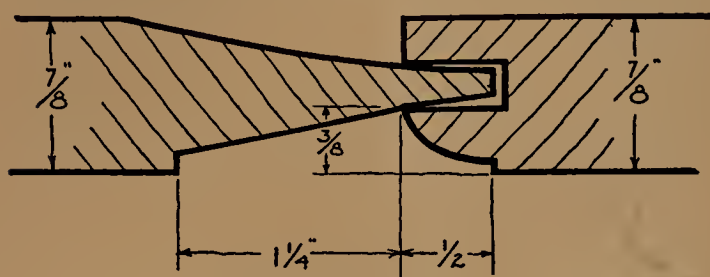
FIGURE 174.

With but few exceptions, the panel section is always the same, consisting of a bevelled edge of 1 or  $1\frac{1}{4}$  inches and a quarter-round bead measuring about one-half inch in width. (Figure 174.) Rails and stiles were mortised and tenoned together and secured with wooden pegs, usually two to a joint, about one-fourth of an inch in diameter. Stiles and rails were constructed from inch stock, generally left rough and unplanned on the back or chimney side. The panels themselves were sometimes constructed of thinner material, three-fourths or seven-eighths of an inch in thickness.
